Arboricultural Impact Assessment

Butterfly / Glöyn Byw Solar Farm

Applicant	RWE Renewables UK
Agent	AXIS P.E.D LTD
Site Address	South of Wrexham, adjacent to the A483, between Johnstown to the west and Bangor on Dee in the East and north of the B5426.
Arboricultural Consultant	Mike Wood <i>Dip Arb. TechArbor A</i>
Local Authority	Wrexham County Borough Council
Proposal	New solar energy generating station, associated on-site Battery Energy Storage System (BESS), access tracks and substation.
Survey Date	August and September 2023, May 2025
Report Date	9 th September 2025
Report Reference	250904-1.4-AIA-BSP-T21-MW

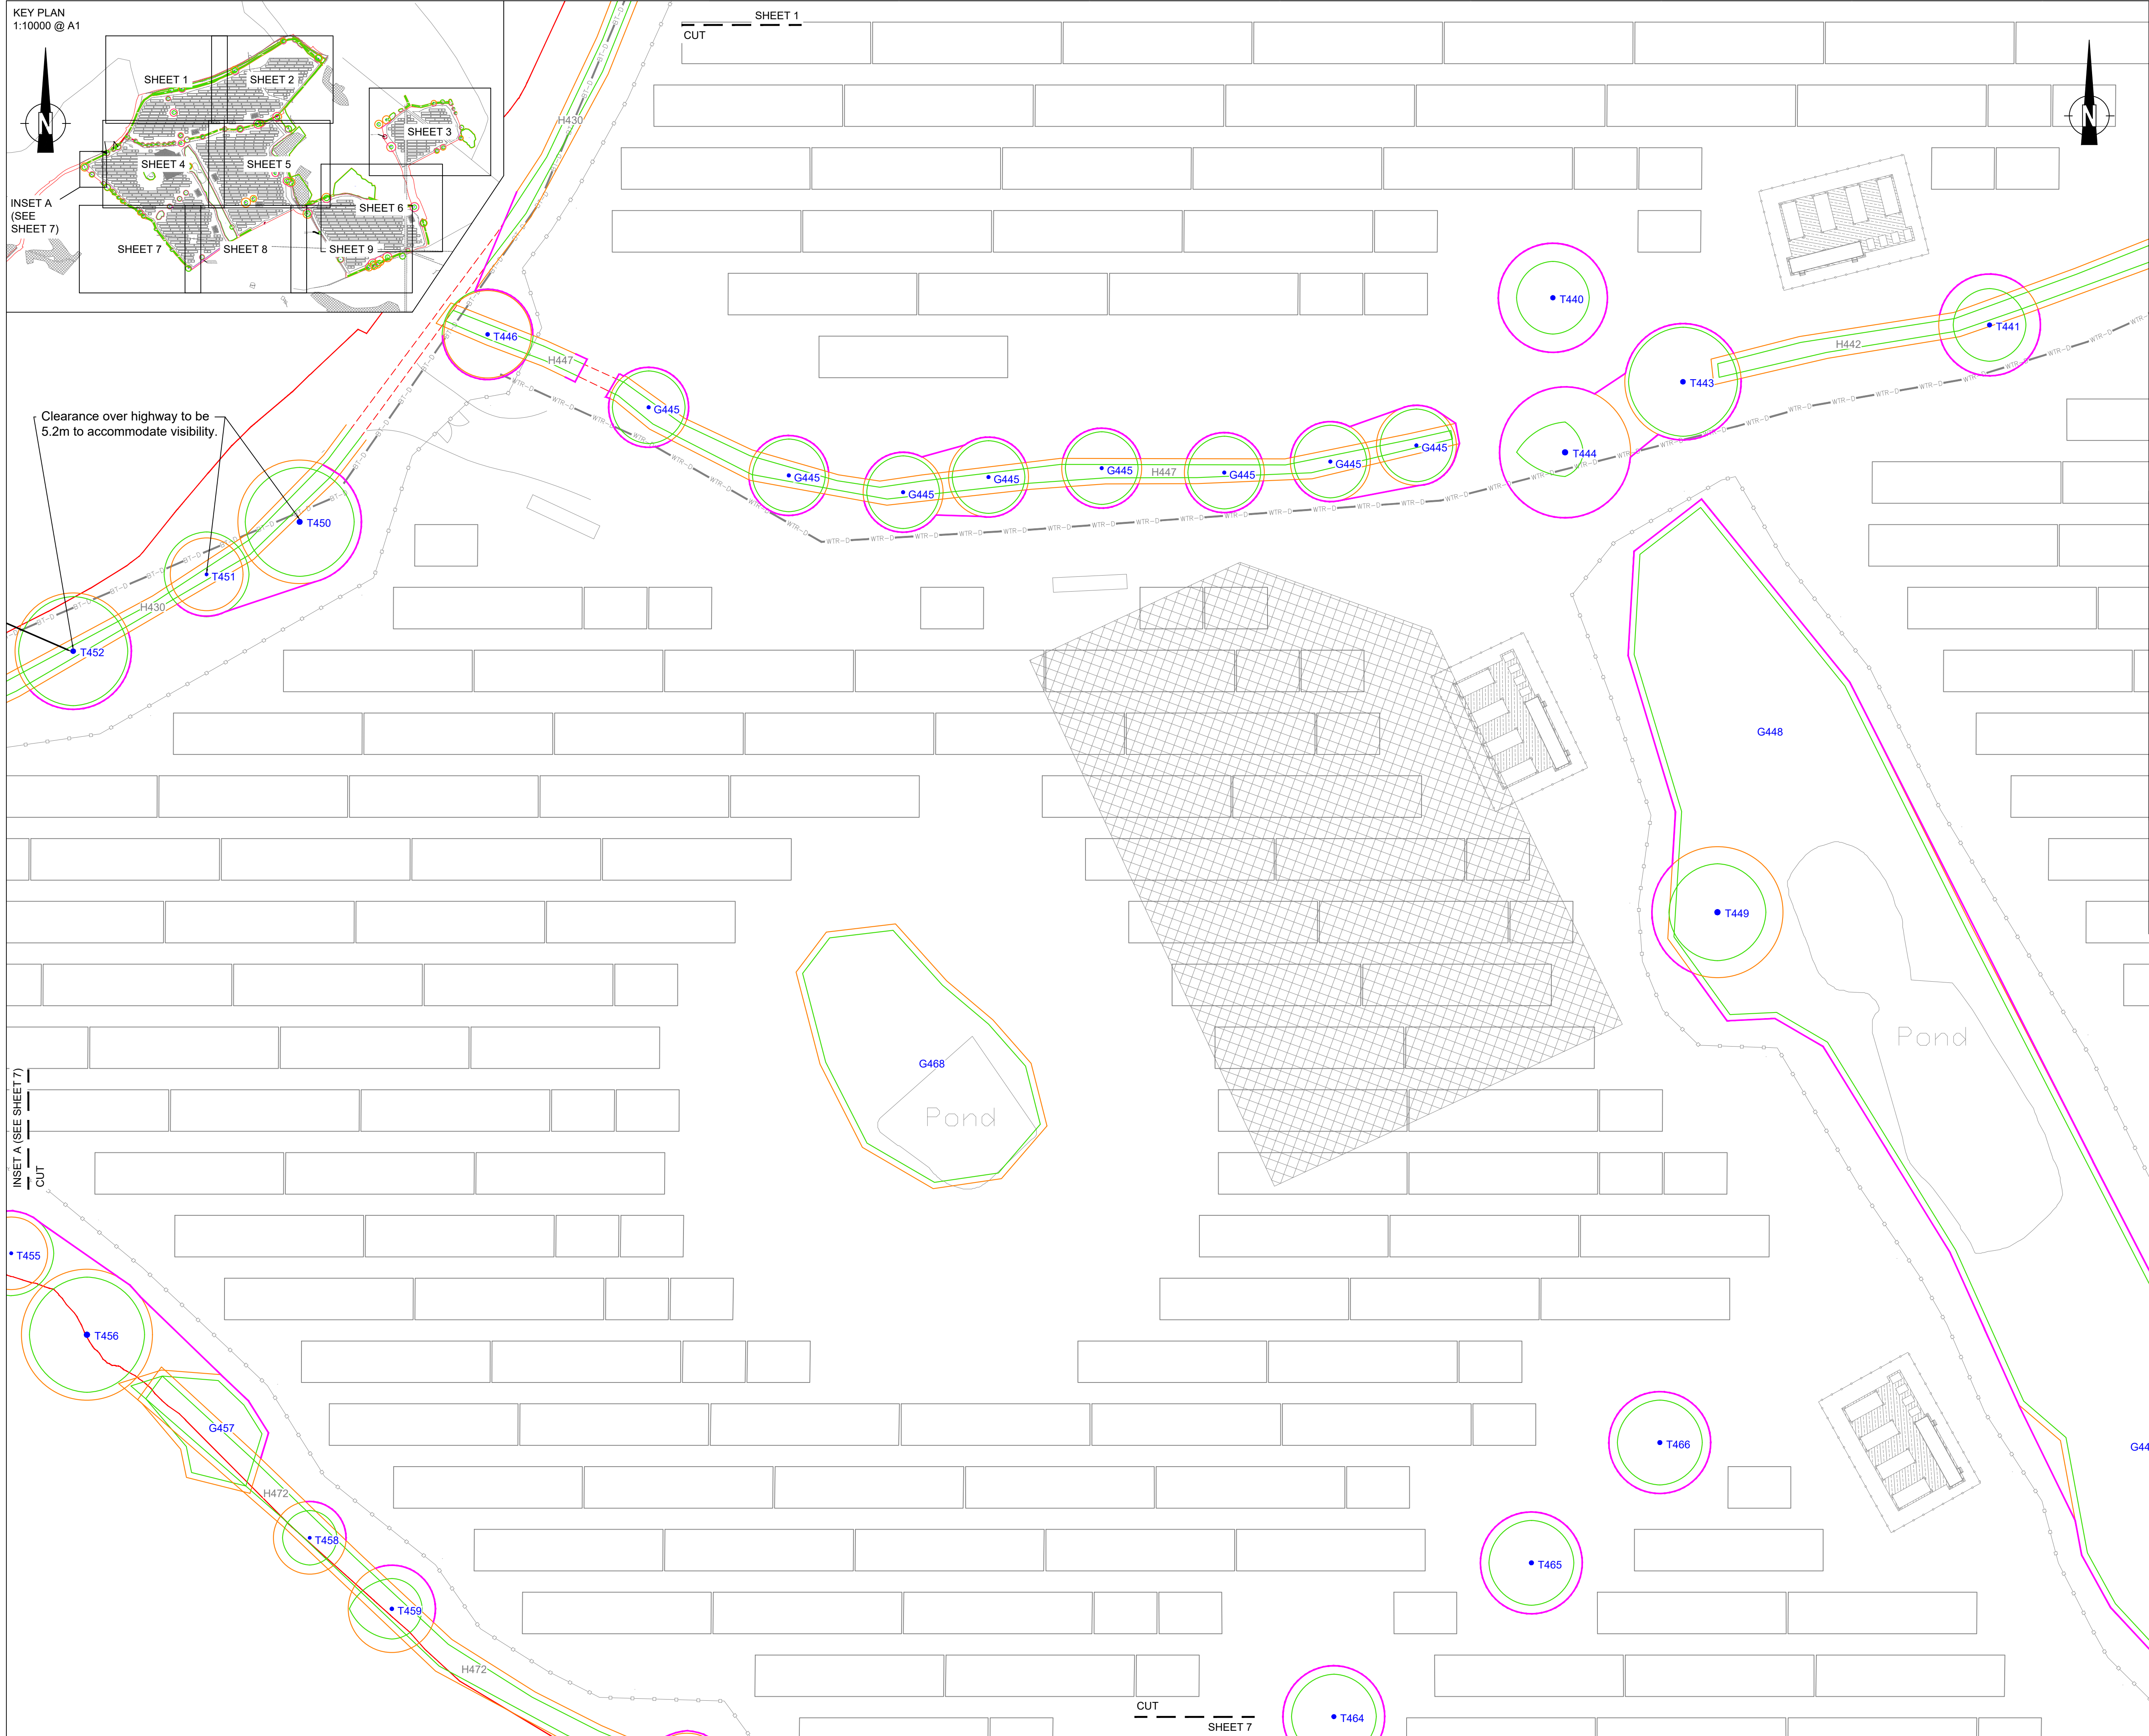
SHEET 6

Project Name:	Butterfly Solar Park - East
Drawing Title:	Tree Protection, Retention & Removal Plan Sheet 6
Drawing Number:	250310-2.1-LSPE-TPRRP-MH-06
Client:	RWE
Agent:	AXIS
Date:	September 2025
Scale:	1:500 @ A1

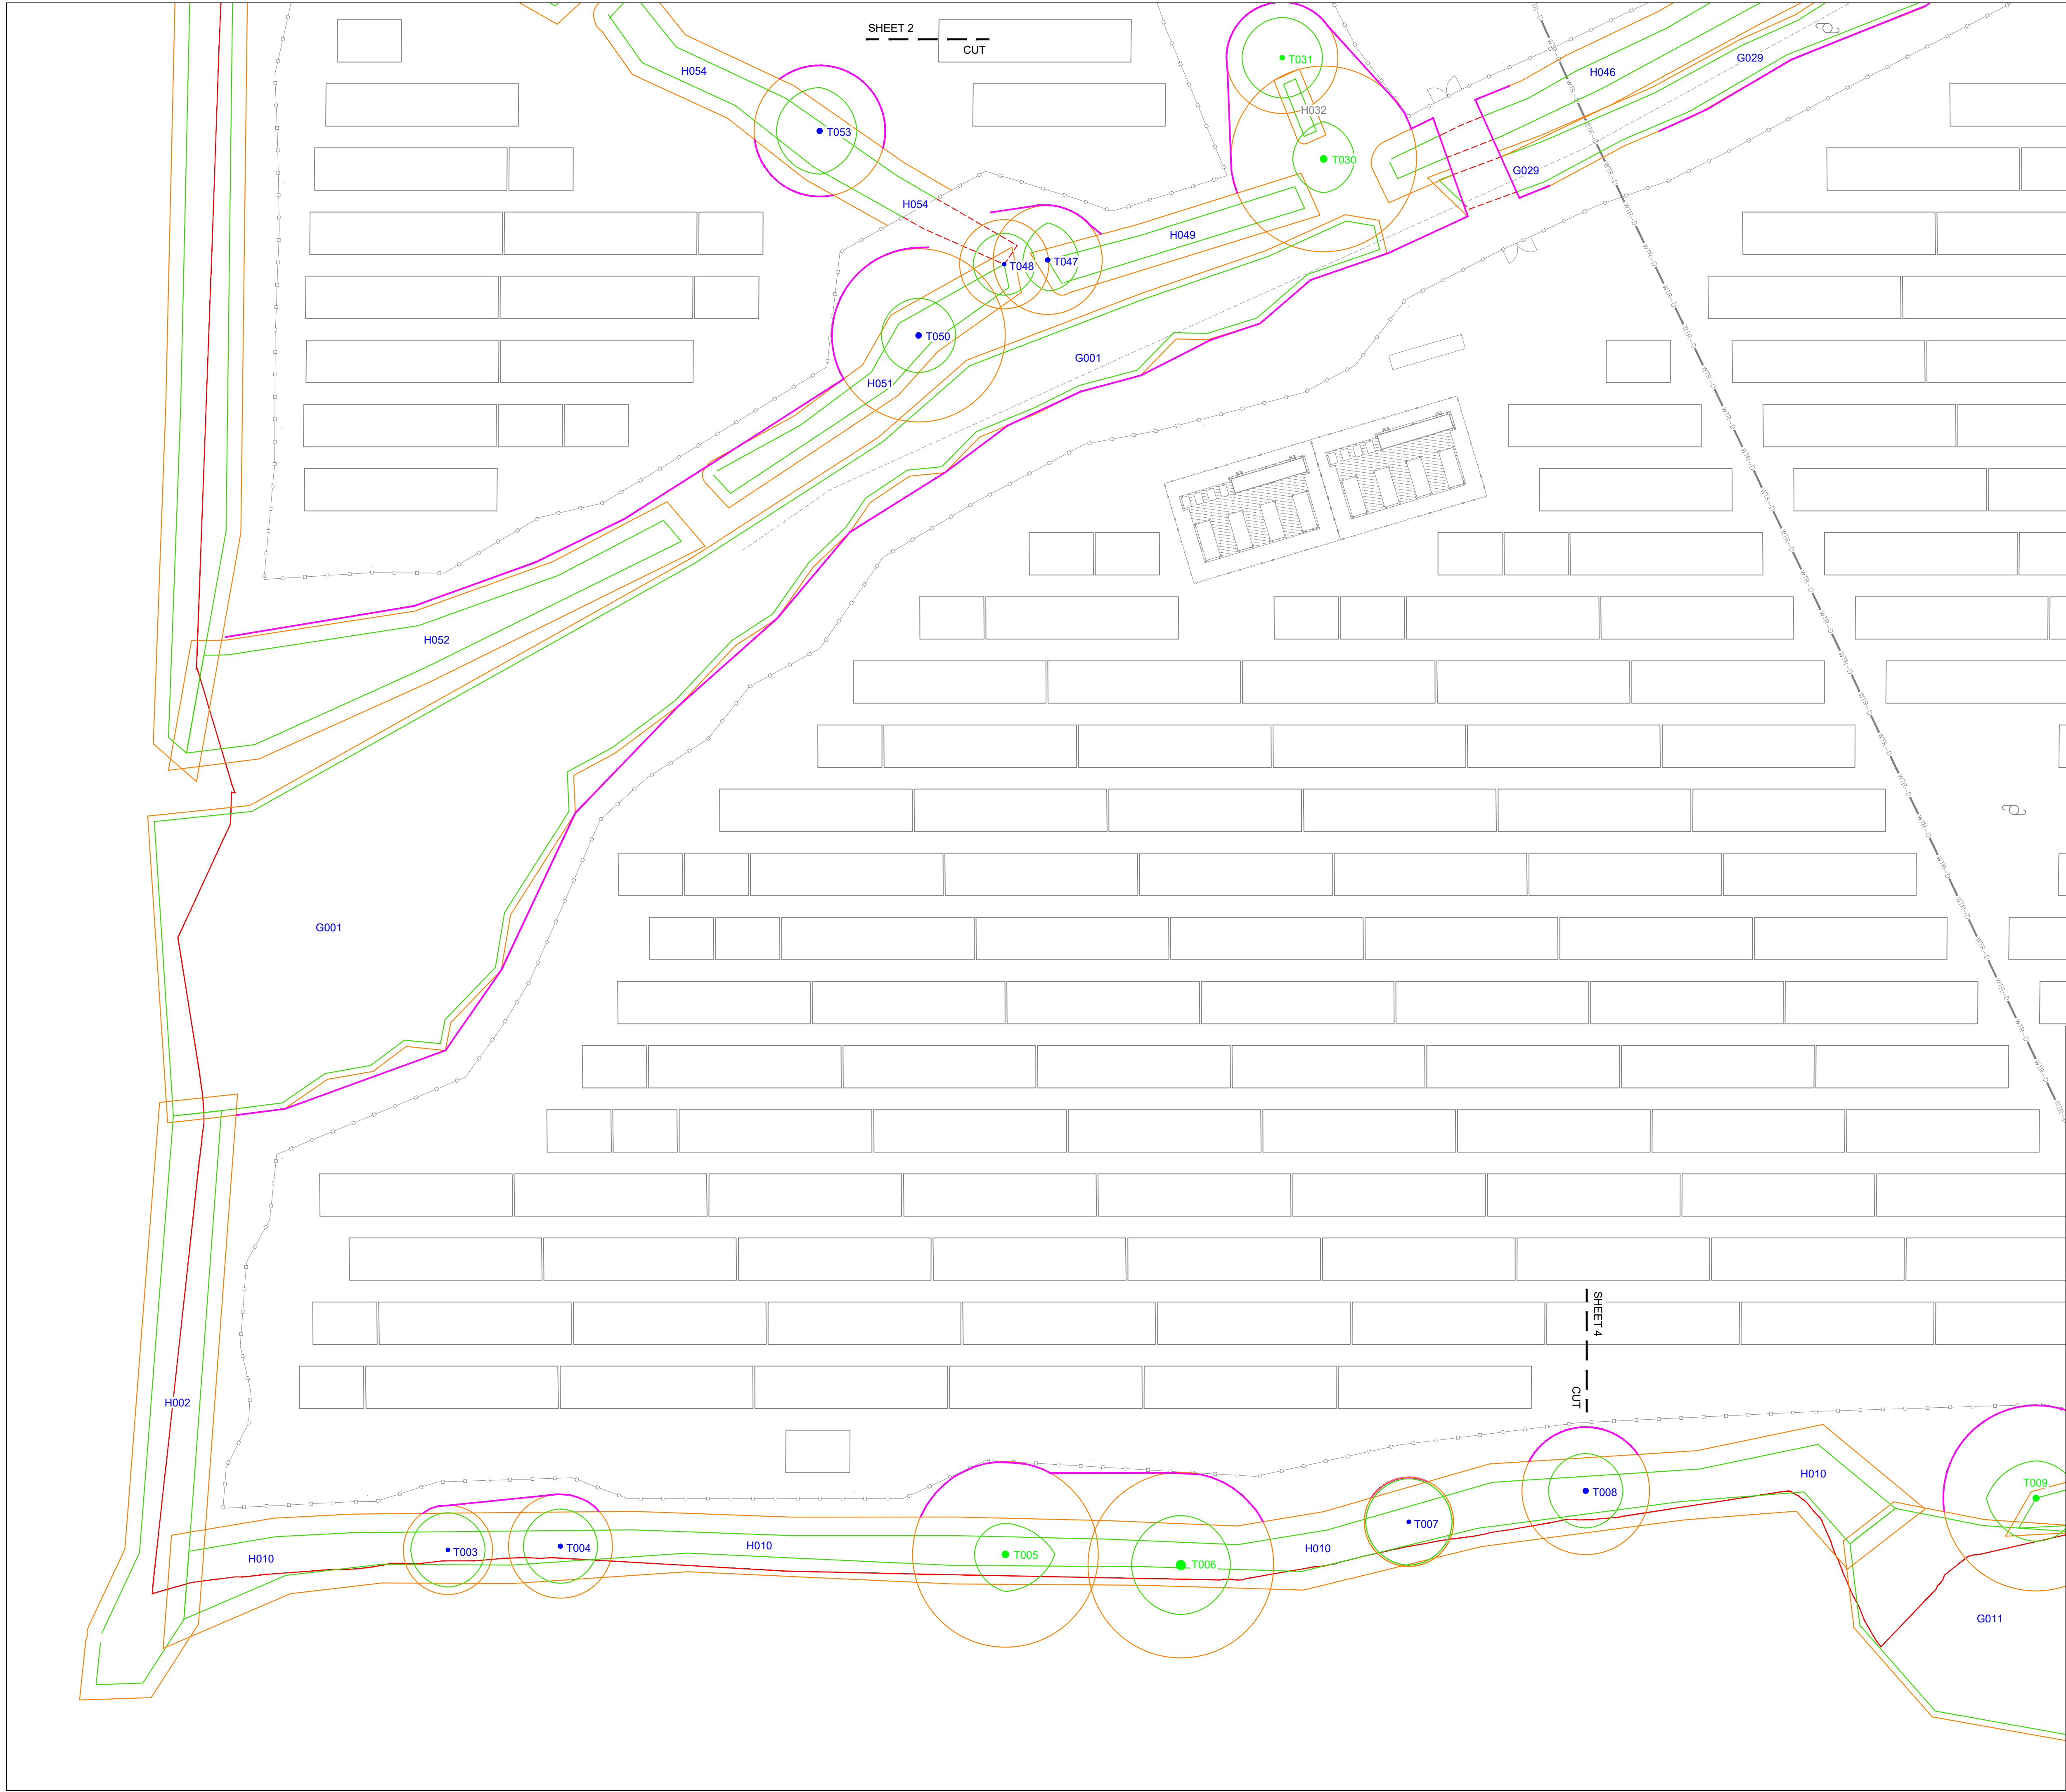
Project Name:	Butterfly Solar Park - West
Drawing Title:	Tree Protection, Retention & Removal Plan Sheet 5
Drawing Number:	250805-1.1-LSPW-TPRRP-MH-05
Client:	RWE
Agent:	AXIS
Date:	September 2025
Scale:	1:500 @ A1
