## Peat Slide Risk Assessment

## Enoch Hill Wind Farm

### Peatslide Hazard and Risk Assessment

July 2015

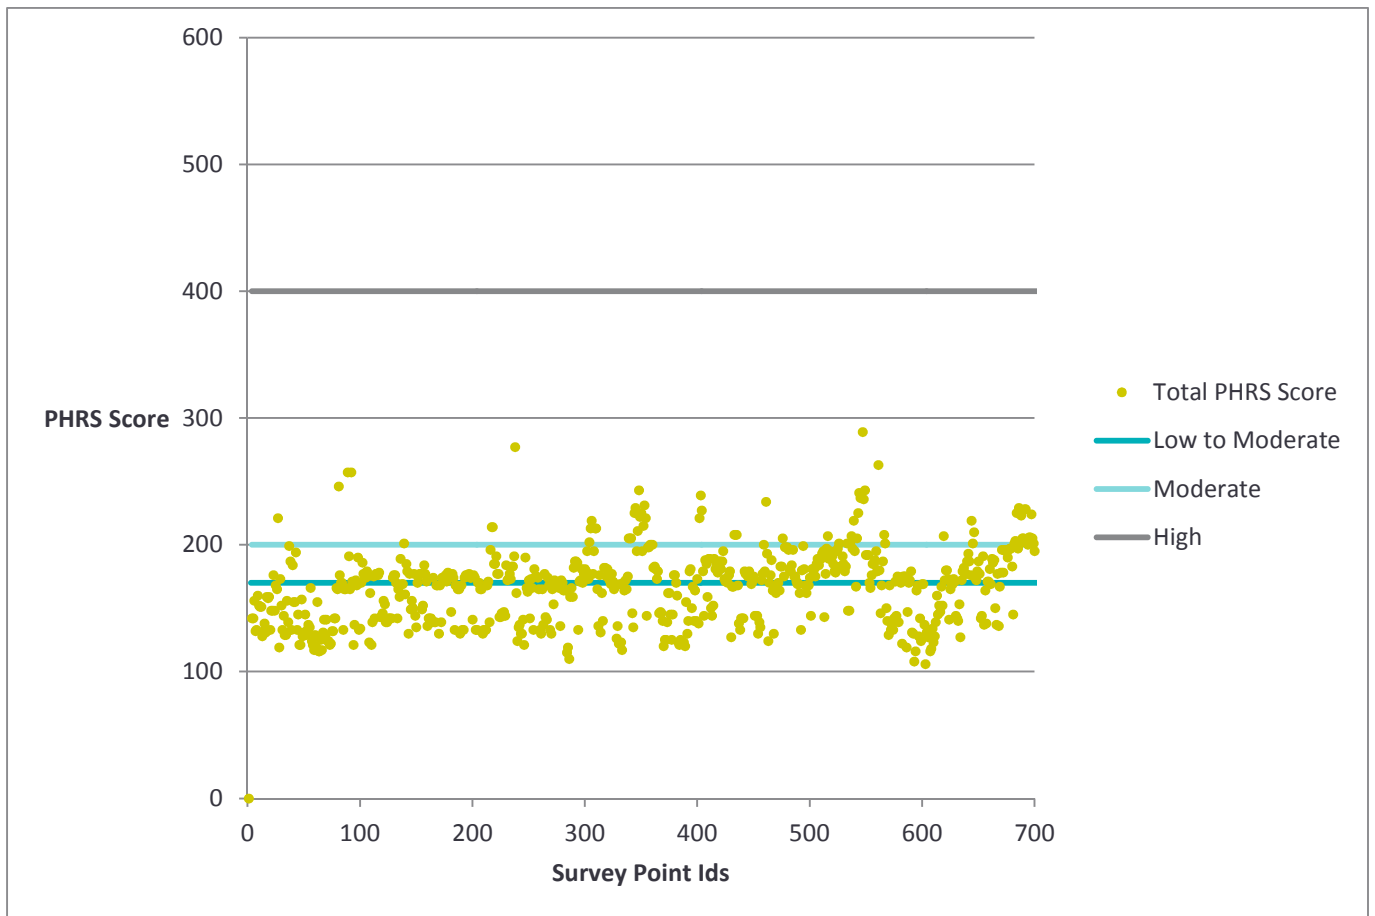
Plate 1: Peat Hazard Rating System Scores

Level of Risk	PHRS Score	No. of Points
Low	0 – 170	342 (49%)
Low to Moderate	171 – 200	280 (40%)
Moderate	201 – 400	78 (11%)
High	401 - 600	0 (0%)

As detailed in Table 5.2, 78 No. phase 2 survey points have PHRS scores that are considered to represent areas that are moderately susceptible to peatslides. In general areas of moderate risk correspond with areas of deeper peat where peat depths are up to 2m or more, such as the locations of turbines T2, T7, T17 and T19 in the west and south west of the Development Site. In addition, PHRS scorings reveal that 280 of the 700 phase 2 survey locations are considered to have a low to moderate peatslide susceptibility. Although approximately 40% of the Development Site is considered to have a low to moderate or moderate susceptibility to peatslides, a review of the PHRS scorings reveals that a significant proportion of all the total PHRS scores are driven by the climate score which is 91 due to the relatively high average rainfalls that are anticipated.

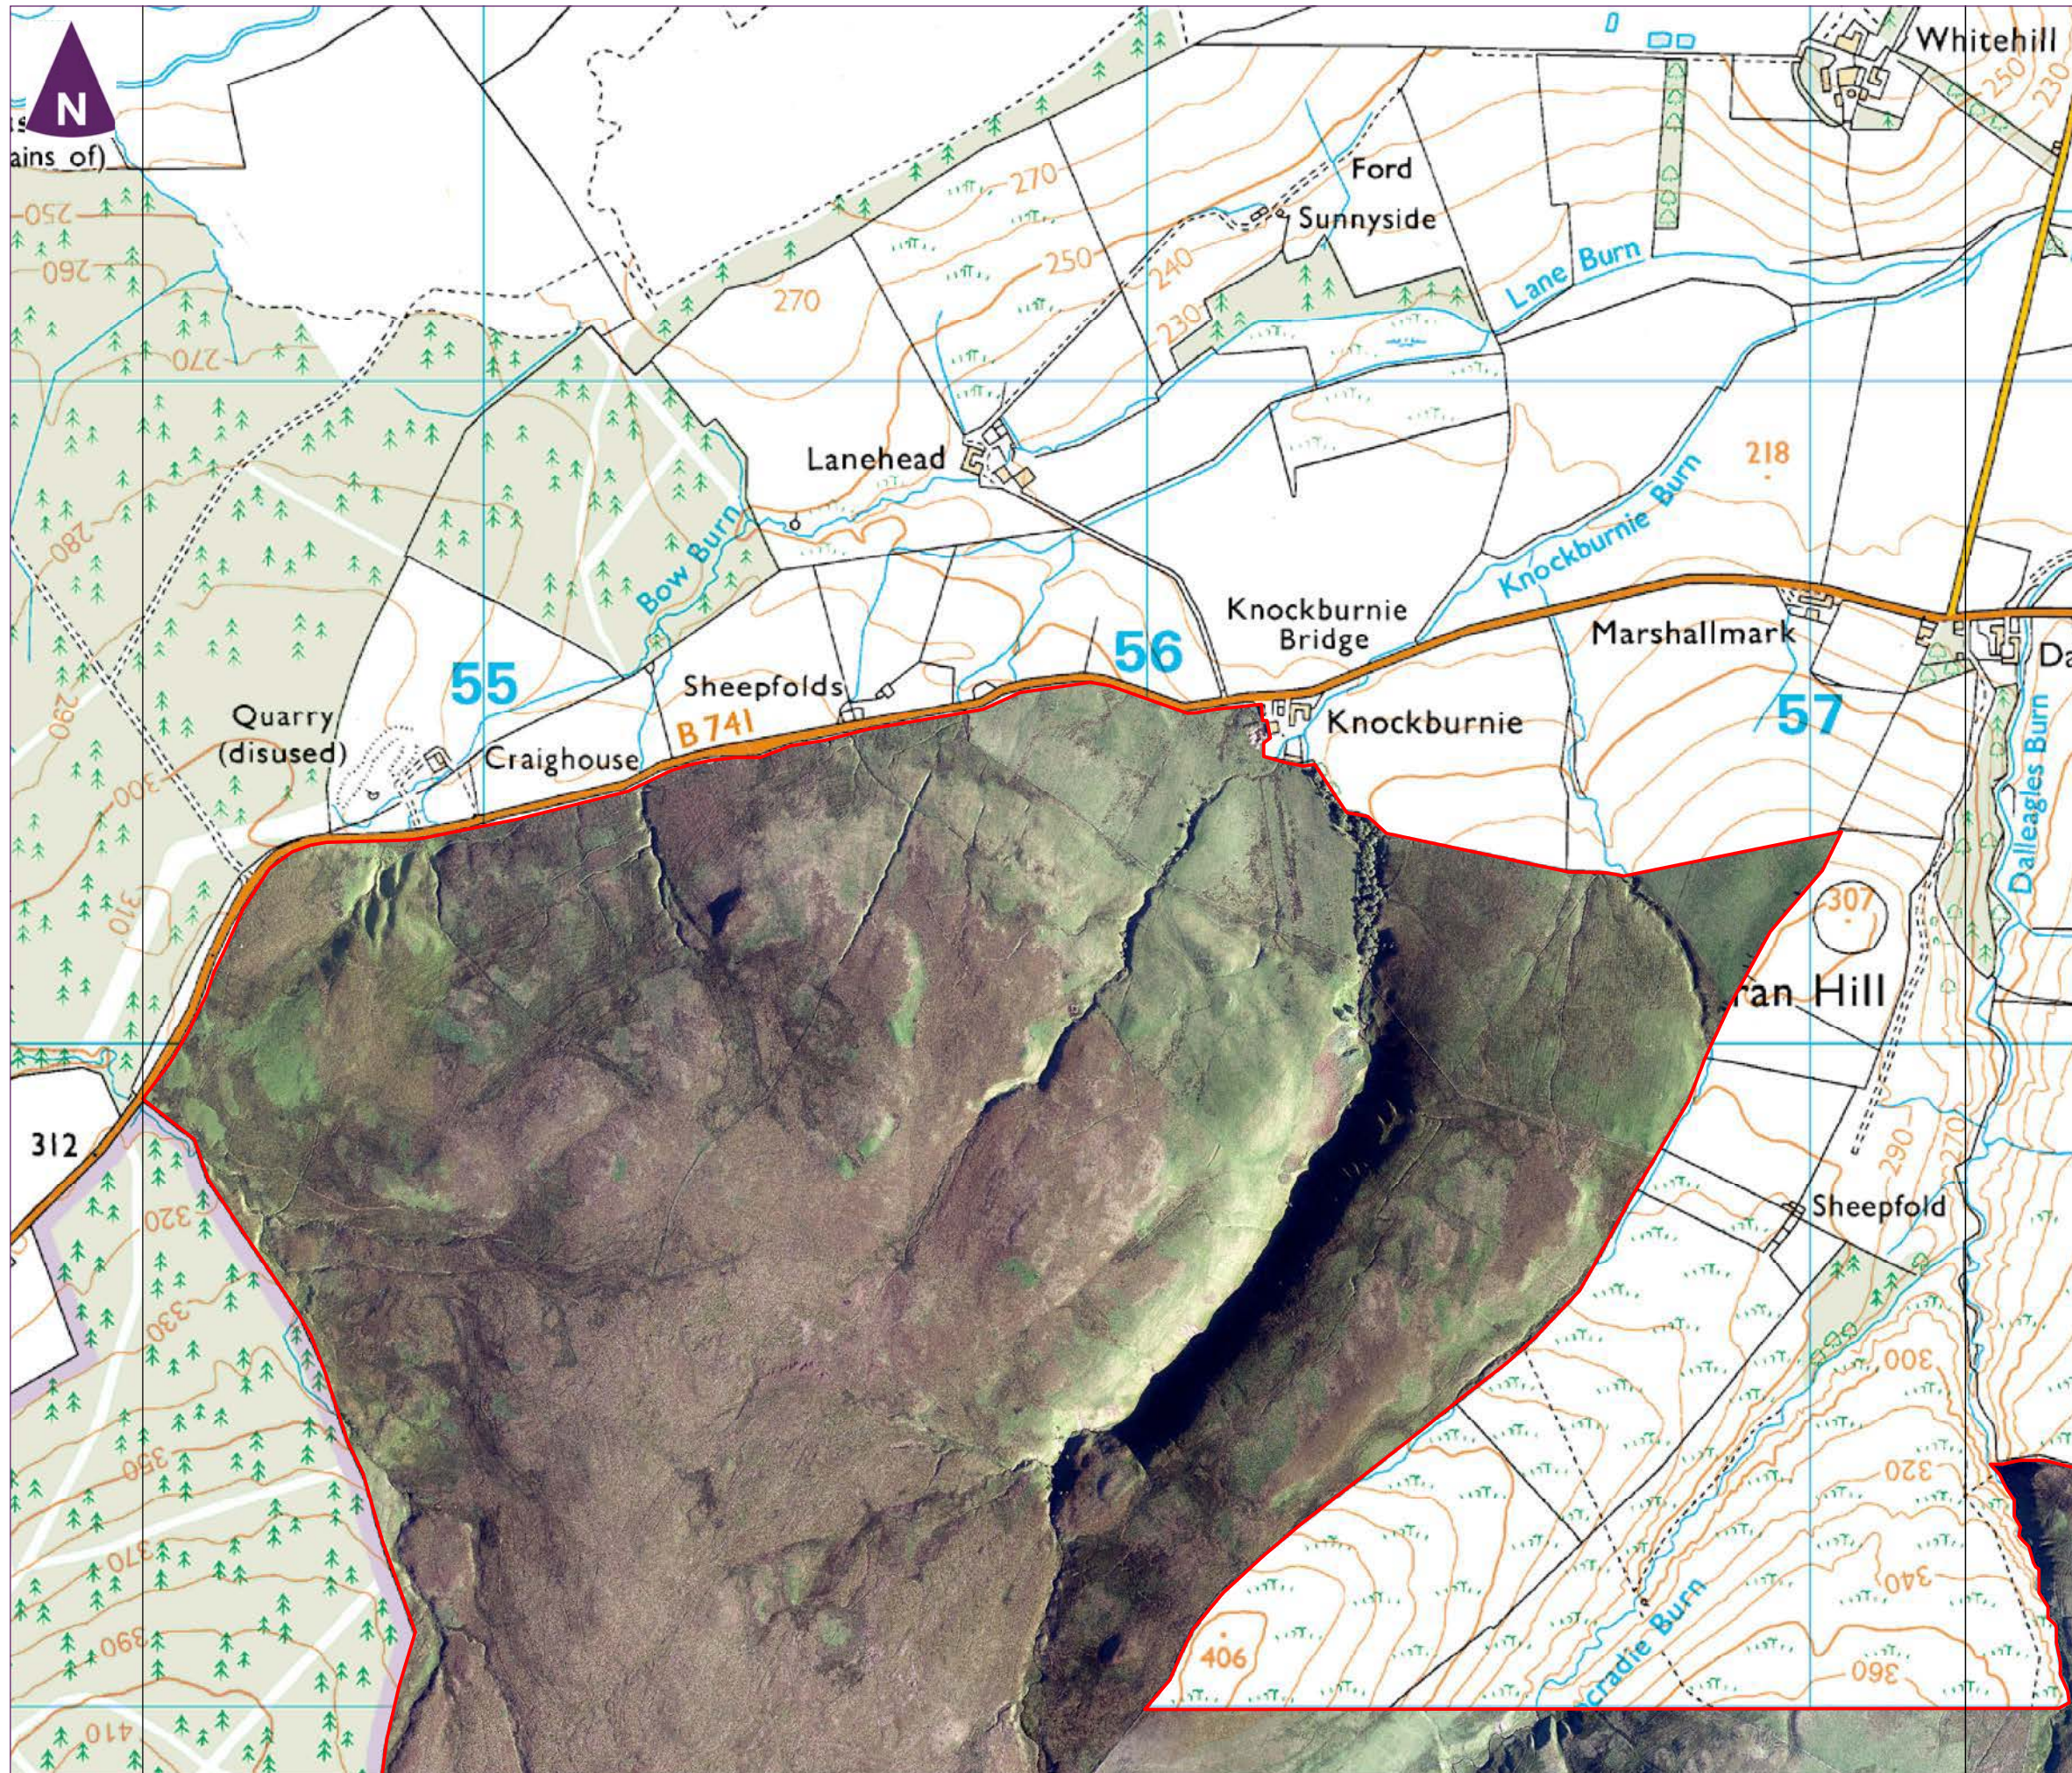
**Figure 6.1**  
Aerial Photography

A review of contemporary aerial photography (Getmapping Plc, 2010) reveals that the Development Site contains no obvious relic or incipient peat slide features such as indications of backscars, peat slide rafts or run-outs. However, aerial photography reveals that there are numerous mineral soil translational failures along the steep sided valleys of Knockburnie Burn, Crocradie Burn, Catlock Burn and Littlechang Burn. These failures have potentially been caused by over steepening of the slopes by erosion on the outside of stream meanders. These features generally appear as a pronounced arcuate headscarp with downslope run-out of the mineral soils. In addition, bedrock or mineral superficial deposits are visible and the slide has been of sufficient magnitude to have altered the course of the stream in some cases. During the peat surveys a number of the mineral slides were identified on the Development Site, examples of the feature identified are presented in TN 021, 022 and 025 in Appendix C.

The only peat erosion features identified in aerial photography are small areas of haggling located around the source of Littlechang Burn to the west and southwest of T5. In addition areas of flushing and haggling are also identified between T6 and T7, between T10 and T13 and at the Development Site boundary to the south of T3. The aerial photography reveals that the Development Site also has numerous areas where the ground has been drained by gripping of the peaty soils. In general most gripping is low intensity with spacing's typically in the range of less than 15m to 30m or more. The grips are typically aligned down or diagonally along the slope. There are two areas of the Development Site that are intensely gripped with spacing's less than 15m and that often criss-cross wider spaced grips running perpendicular to them. The areas of intense peat gripping are located in the vicinity of turbines T2 and T17 and within the north west of BP-A.
