Enoch Hill Wind Farm

Peatslide Hazard and Risk Assessment
(Further Environmental Information (FEI) Submission)

Enoch Hill Wind Farm - Peatslide Hazard and Risk Assessment (PHRA) - Request for Further Environmental Information Technical Response

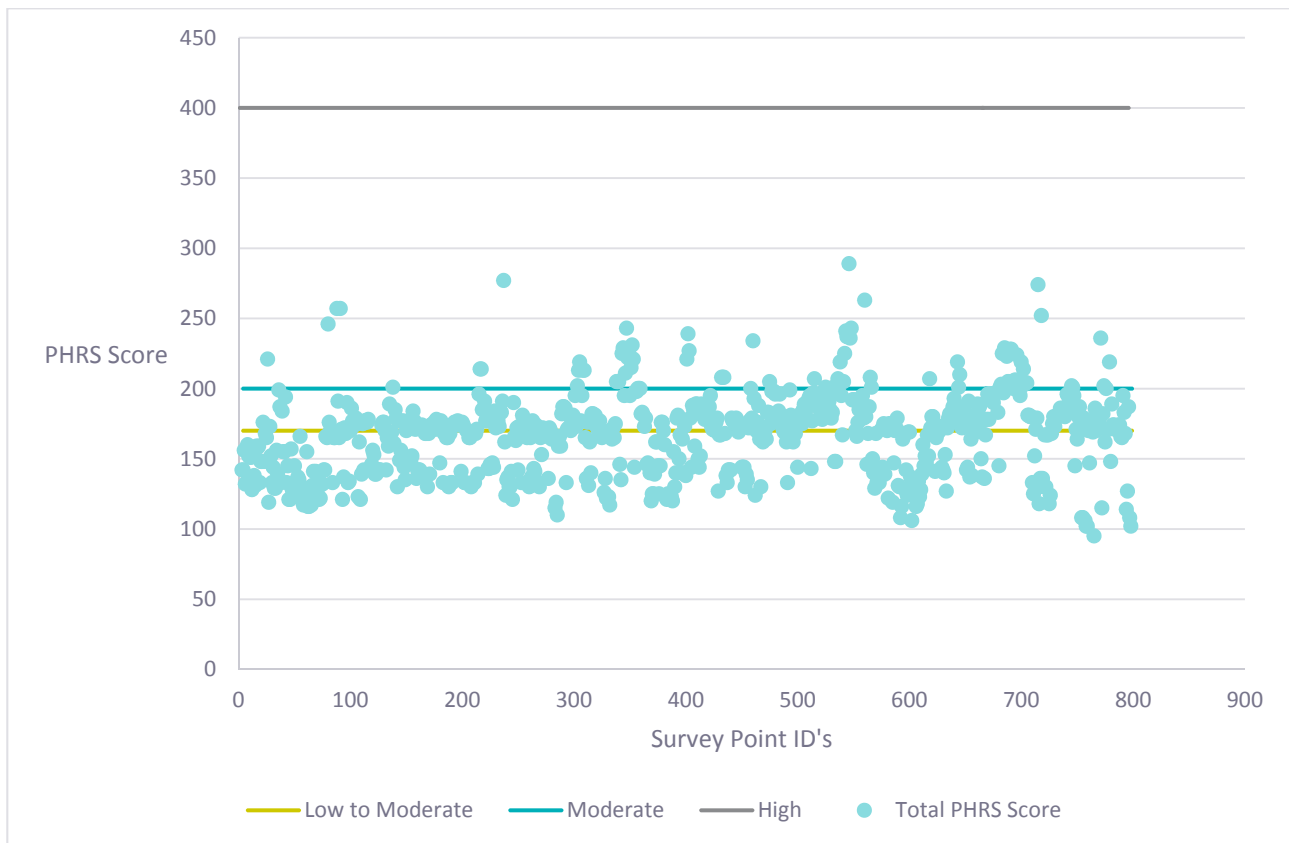
Plate 1: Peat Hazard Rating System Scores

Level of Risk	PHRS Score	No. of Points
Low	0 – 170	306 (51%)
Low to Moderate	171 – 200	244 (40%)
Moderate	201 – 400	46 (7%)
High	401 - 600	0 (0%)

As detailed in Table 5.2, 46 No. Phase 2 survey points have PHRS scores that are considered to represent areas that are moderately susceptible to peatslides. In general areas of moderate risk correspond with areas of deeper peat where peat depths are up to 2m or steeper slopes generally >7°. In addition, PHRS scorings reveal that 244 of the 596 Phase 2 survey locations are considered to have a low to moderate peatslide susceptibility. Although approximately 40% of the Development Site is considered to have a low to moderate or moderate susceptibility to peatslides, a review of the PHRS scorings reveals that a significant proportion of all the total PHRS scores are driven by the climate score which is 91 due to the relatively high average rainfalls that are anticipated.
